# Investigating the reactivation potential of an ancient landslide in the second lot of the Miyaneh-Ardabil railway

**Abstract**— In this study, a huge old landslide located at the chainage of 370 km of the second lot of the Miyaneh-Ardabil railway has been investigated. What makes this old landslide important is the presence of large bridge (# 12) on the railway route at the toe of this landslide. This landslide has occurred in geological units which consist of volcanic and pyroclastic rocks, mainly tuffs, andesitic tuffs, and andesites. In some parts of the study area, these geological units are geotechnically very weak and do not have favorable quality due to weathering of rock masses and occurrence of fault zones. The results of studies show that the main cause of landslides is the saturation of geotechnical materials due to long-term precipitations and the occurrence of medium to high magnitude earthquakes in the surrounding areas (according to high seismicity of the area). This study aims to investigate the engineering geological features of this large and old landslide and to provide solutions to reduce its risk. For this purpose, after evaluating the geotechnical parameter

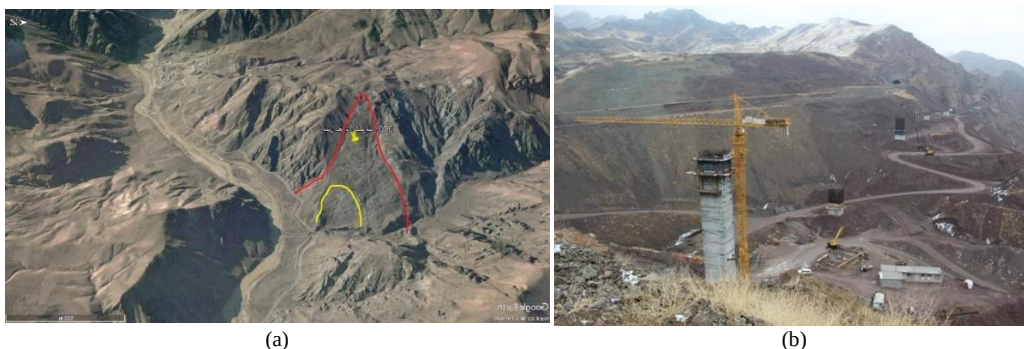
Figure 1 - 370 km landslide a) Image is taken from Google Earth from the landslide area, the yellow part of the smaller and newer landslide that has occurred in the displaced mass. b) Picture of Bridge No. 12 to the northeast

Landslide 370 is an old landslide (Figure 1) that has occurred in a geologically dynamic region in the past. The exact age of the landslide is unknown, but due to morphological evidences a range of 100-200 years can be considered as an approximate age. As shown in Figure 1-b, due to the passage of the railway route (and a large bridge -No. 12- which is being constructed on nine concrete piers named P1 to P9) from the landslide toe, there are concerns about the possibility of reactivation of the landslides and the impact of the new movements on the stability of the bridge piers.

Because there is no evidence of new movements, the main landslide can be classified as inactive and dormant [9]. A dormant landslide is an inactive landslide which can be reactivated by its original causes or other causes. In addition to the main landslide, there is a minor landslide (Figure 1a) in the main landslide due to the construction of the access road to the Shahriar Dam. During earthmoving operations for excavating road cuts, some new tensile cracks created in the accumulation zone of old landslide and new landslide formed in the toe area. This indicates that the road cuts with the designed slopes in loose and weathered materials have not been stable (Figure 2).

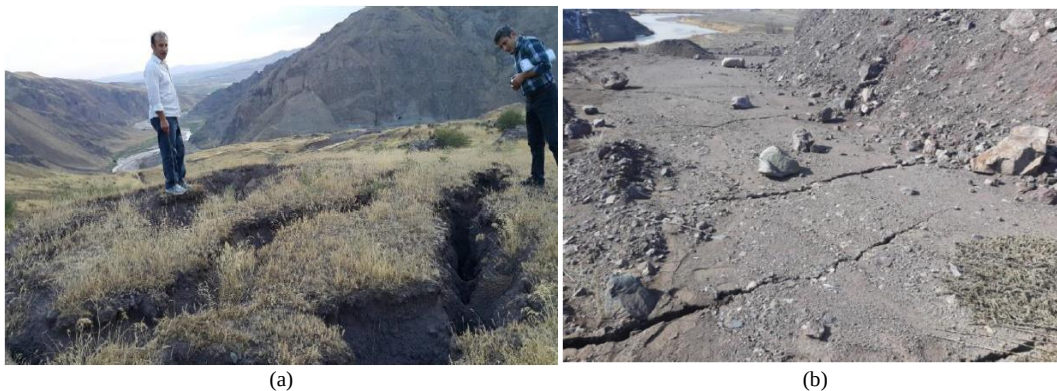
Figure 2 - a) Cracks created near the slippery toe caused by local instabilities in the toe. b) Tensile cracks created in the coated materials forming the downstream slopes of the bridge
